### Practical experience from actual water mist installations. What can be learnt?

Magnus Arvidson

SP Technical Research Institute of Sweden

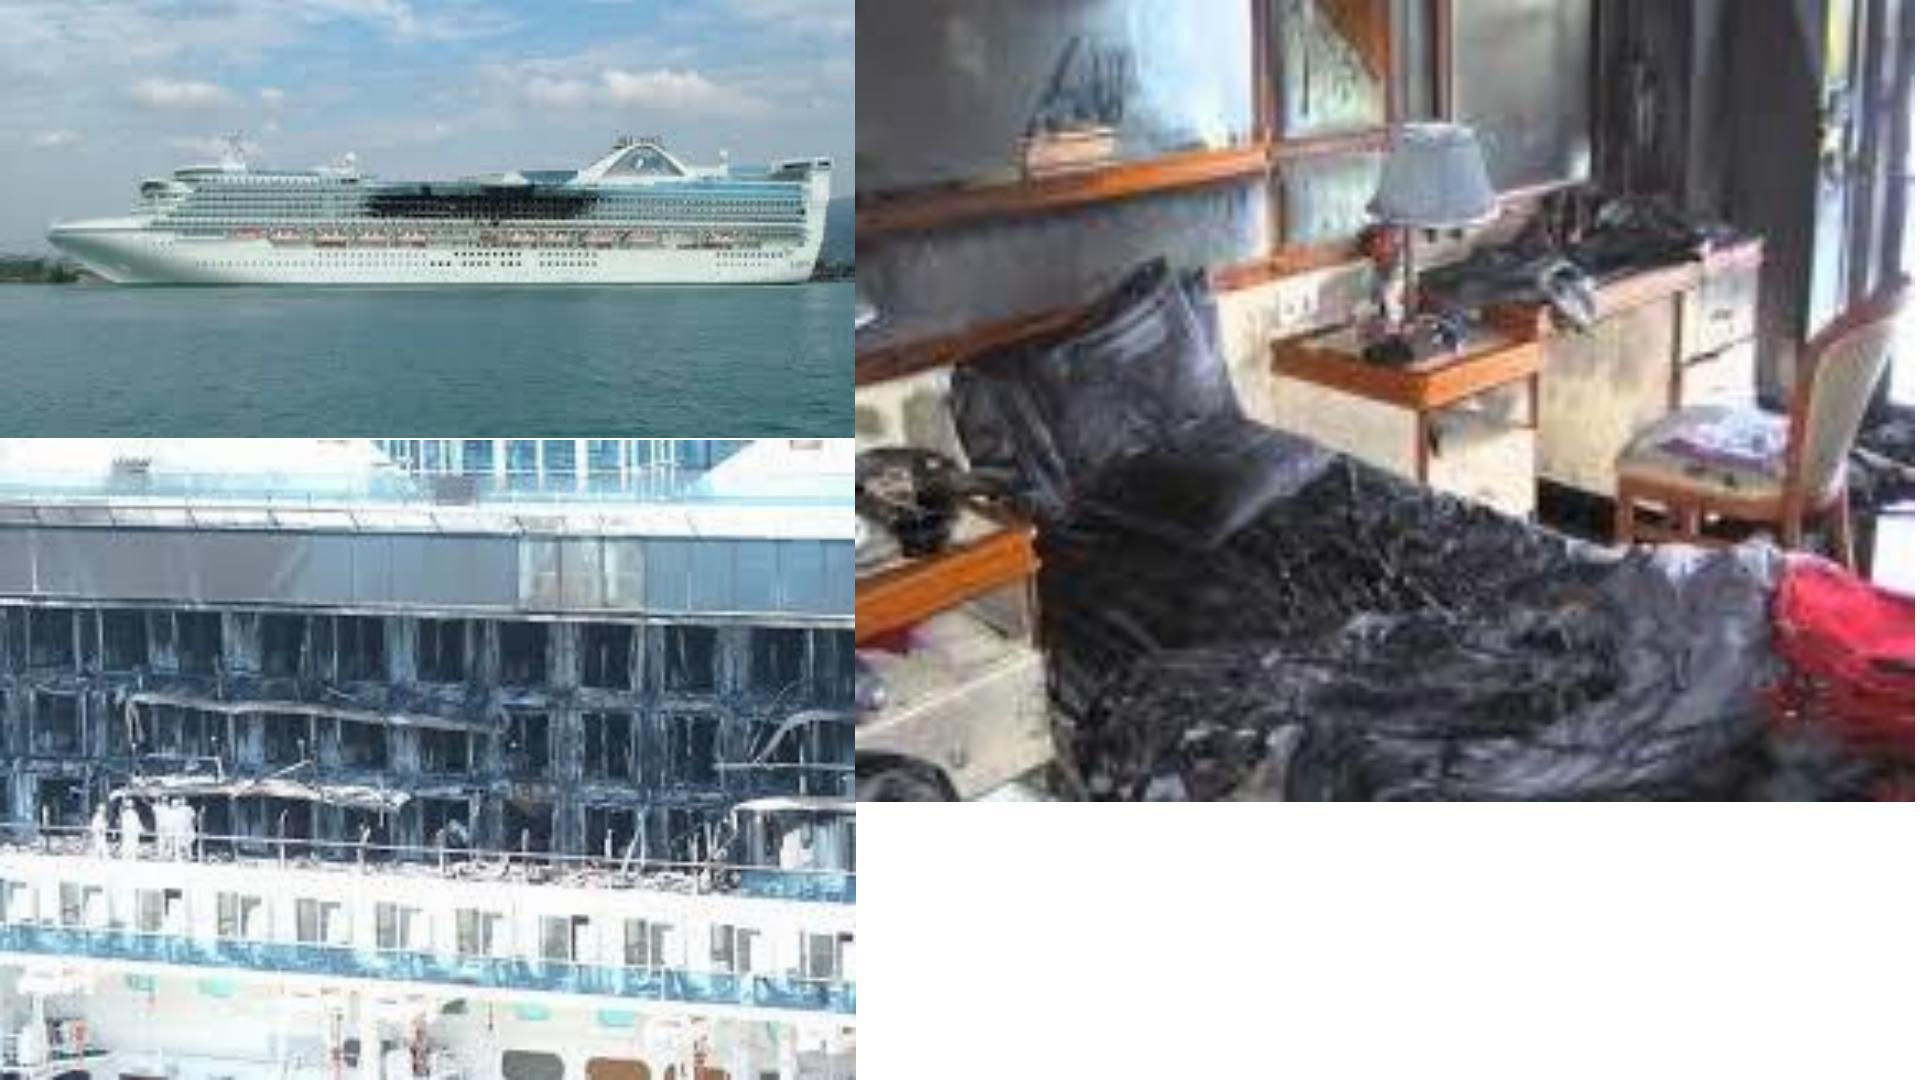
### **Star Princess fire**

- Fire broke out on 23 March 2006, at about 3 am.
- Started on balcony, amidships, on the port side of the ship.
- 2690 passengers and 1123 crew members on board.
- 79 cabins destroyed and a further 204 damaged.
- One passenger died due to inhalation of smoke and toxic gases.
- Thirteen other passengers suffered significant smoke inhalation.

- The high-pressure system was designed for an operating area of 280 m<sup>2</sup> (about 18 nozzles) at an operating pressure of 60 bar.
- Approximately 168 nozzles activated.
- The system was operating for four hours.
- The system pressure was approximately 48 bar, using two regular pump units and a third pup unit that was manually started.
- About 300 tons of water was distributed over three decks and three main vertical fire zones.
- Eight nozzles did not activate properly. For seven of them, this was due to defective glass bulbs.

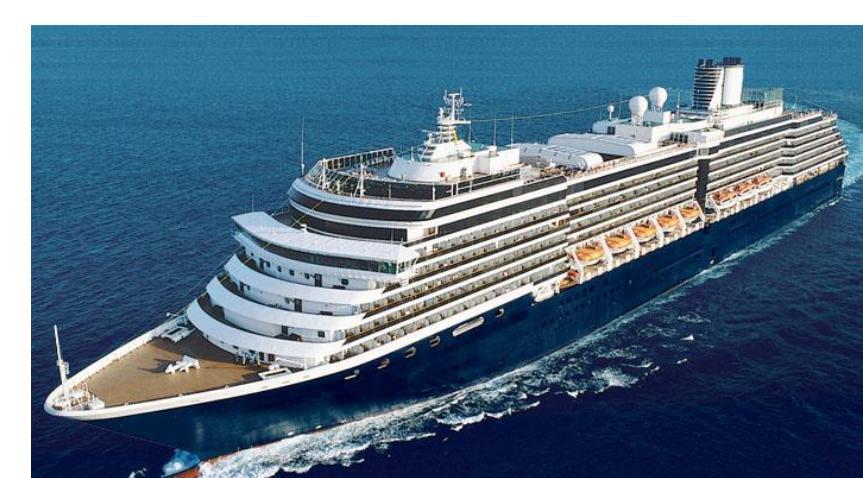
## Problems with automatic nozzles (survey by DNV)

In 2012, Det Norske Veritas did a survey on four passenger ships older than ten years. The results showed that:

- Between 30% and 67% of the nozzles that were tested did not activate.
- Problems were associated with one particular make and type of nozzle.
- Further studies were recommended.

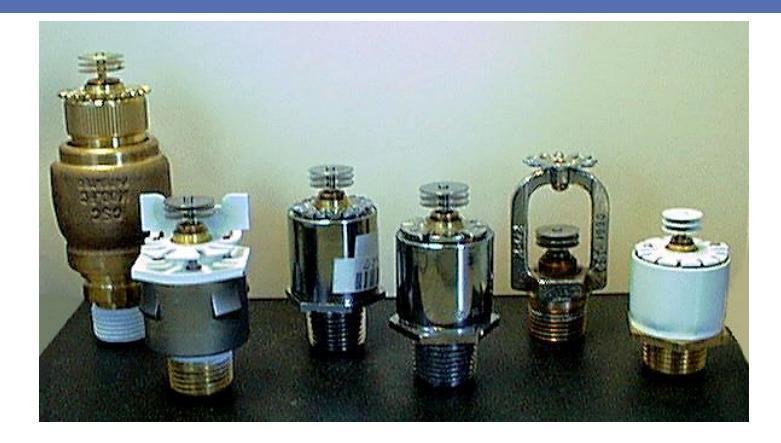
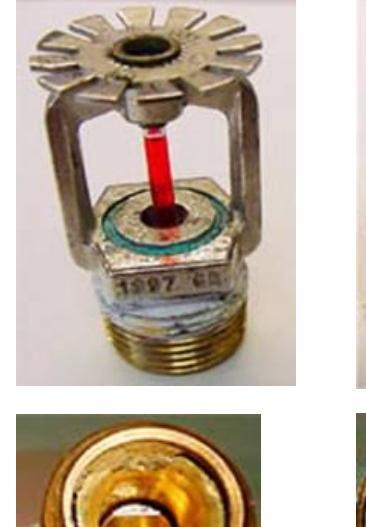
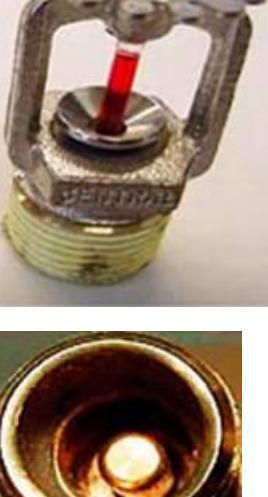
### "Sprinkler recalls" – Central Omega sprinkler

**65 different** models – using O-Ring type water seals – totaling approximately **35 million** Central fire sprinklers.

Manufactured 1982 – 2000.

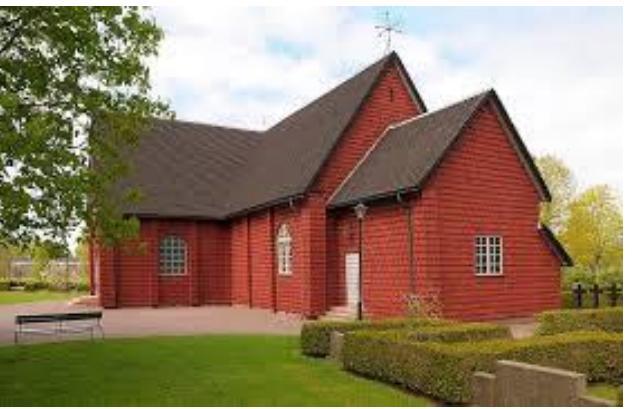
- Gas driven pump unit located in a 10 m<sup>2</sup> room in basement.
- Access only possible via a stair from the floor above.
- Approximately 30 Nitrogen cylinders.

Accidental activation of the system. Due to a technical failure, all gas entered the room. The caretaker entered the room but had to evacuate.

- A pipe coupling in the room broke.
- A fireman entered the room but had to evacuate.
- The cutting ring of the coupling was mounted wrong.

Rooms with pressurized inert gases should be accessed directly from the outside.
