Characterizing EV vs ICE Hazards in Parking Structures: Results of Full-Scale Testing

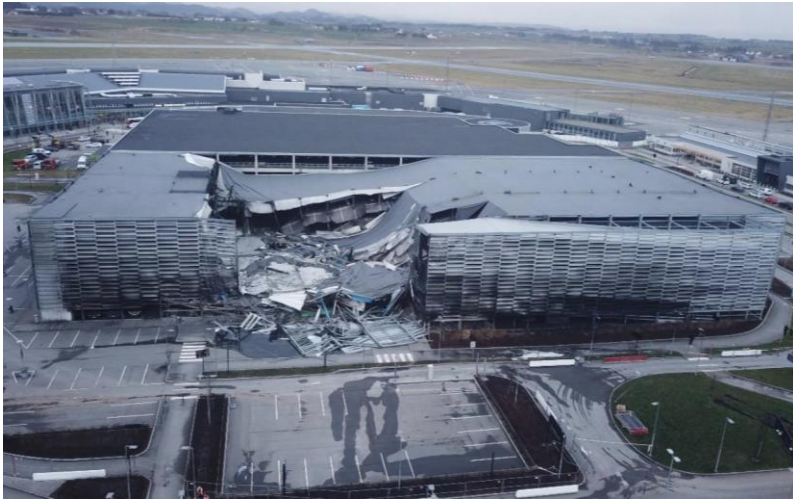
January 7, 2020 - Stavanger Airport, Sola, Norway

- Unsprinklered.
- ICE – Engine compartment fire.
- More than 300 vehicles were involved.
- Partial collapse, unprotected steel, of the structure.

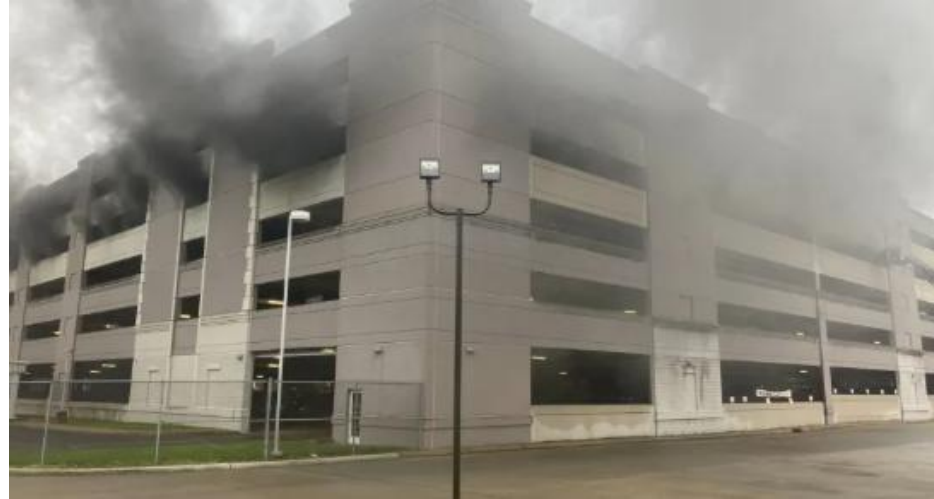
June 23, 2022 - Merriweather District, Columbia, Maryland, United States

- Unsprinklered
- Presumably built before fire codes required sprinkler systems in open-type garages.
- ICE – Engine compartment fire.
- 8 vehicles were involved.
- Vehicle damage at \$70,000 and structural damage to the parking facility at \$100,000.

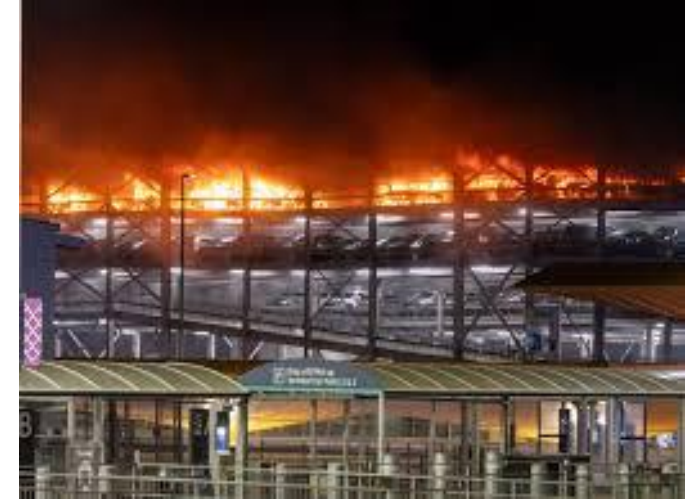
October 10, 2023 - Luton Airport, London, United Kingdom

- Unsprinklered - open-type garages.
- ICE – Diesel engine.
- More than 1,400 vehicles were involved.
- Metal structure collapsed.
