### Practical experience from actual water mist installations. What can be learnt?

Magnus Arvidson

SP Technical Research Institute of Sweden

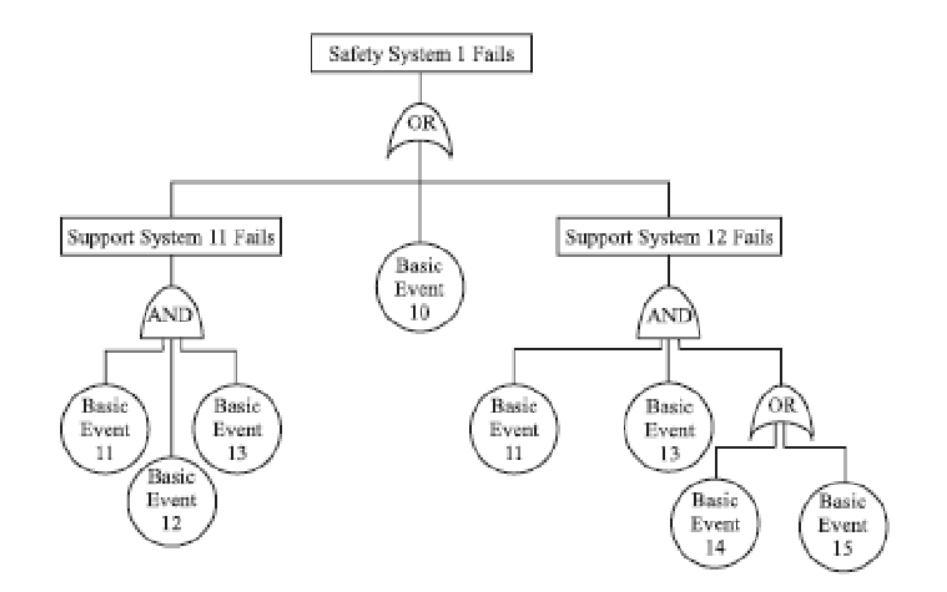
## Water mist system reliability

- To date, there is not enough field experience to judge system reliability.
- Estimation of system reliability need to be based on fault tree analysis.

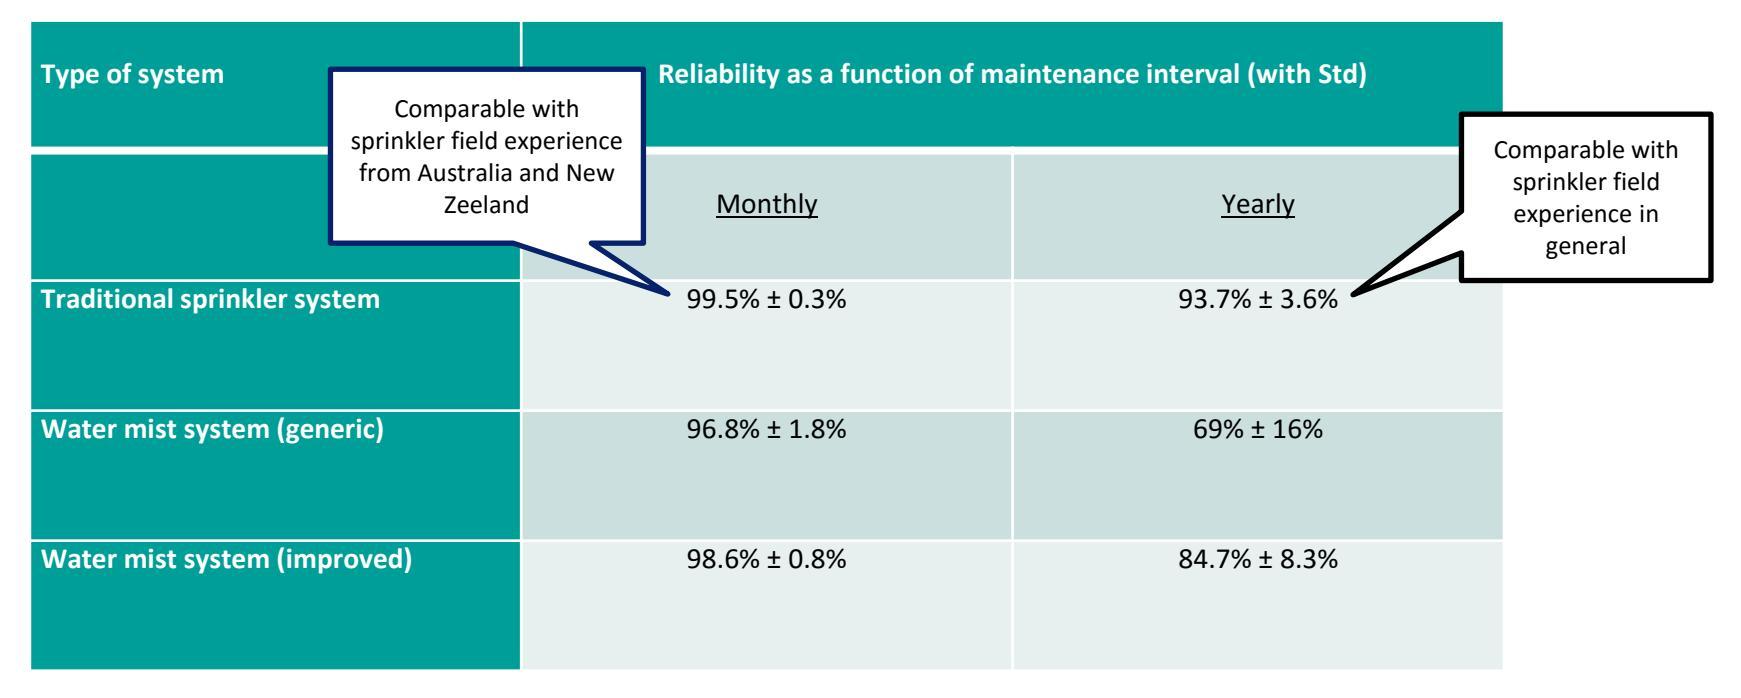
### Fault tree analysis for fire protection systems on passenger ships

- Limited field experience.
- Fault tree analysis indicate a higher probability for failure as compared to traditional sprinkler systems.
- Shorter periodical control and maintenance intervals may be a solution in practice.
