Practical experience from actual water mist installations

Magnus Arvidson Fire Research SP Sveriges Tekniska Forskningsinstitut

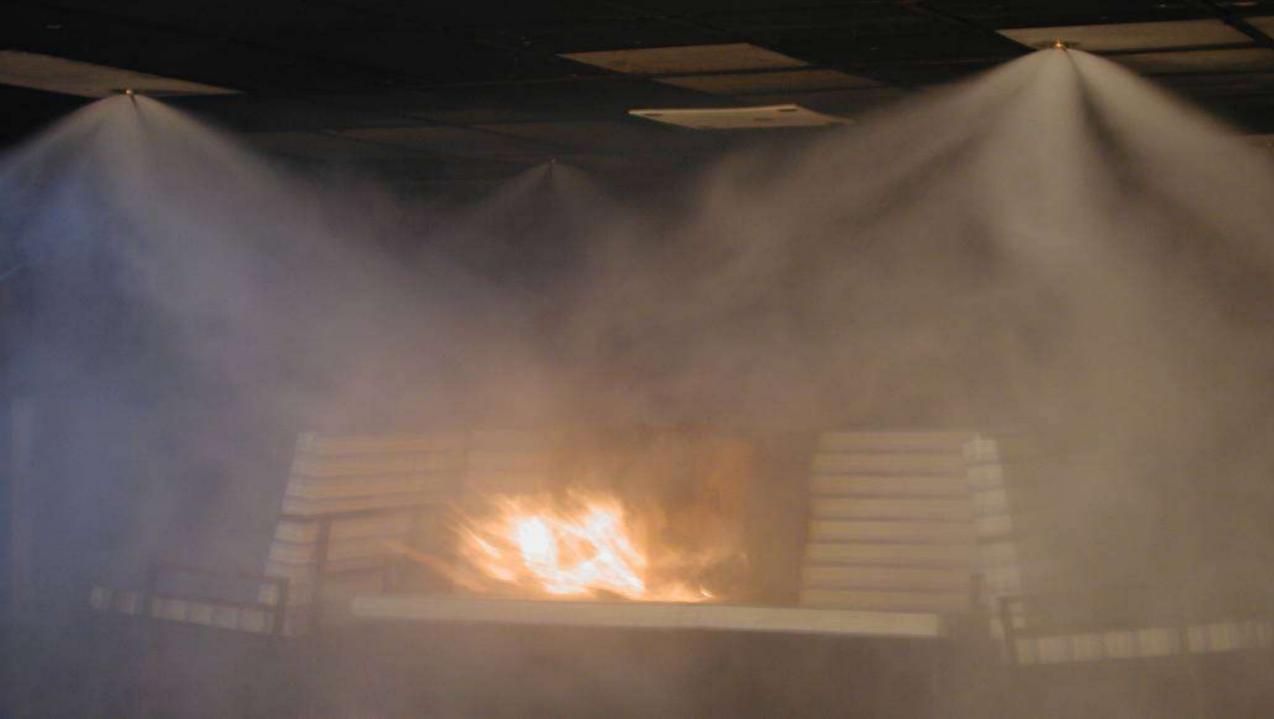
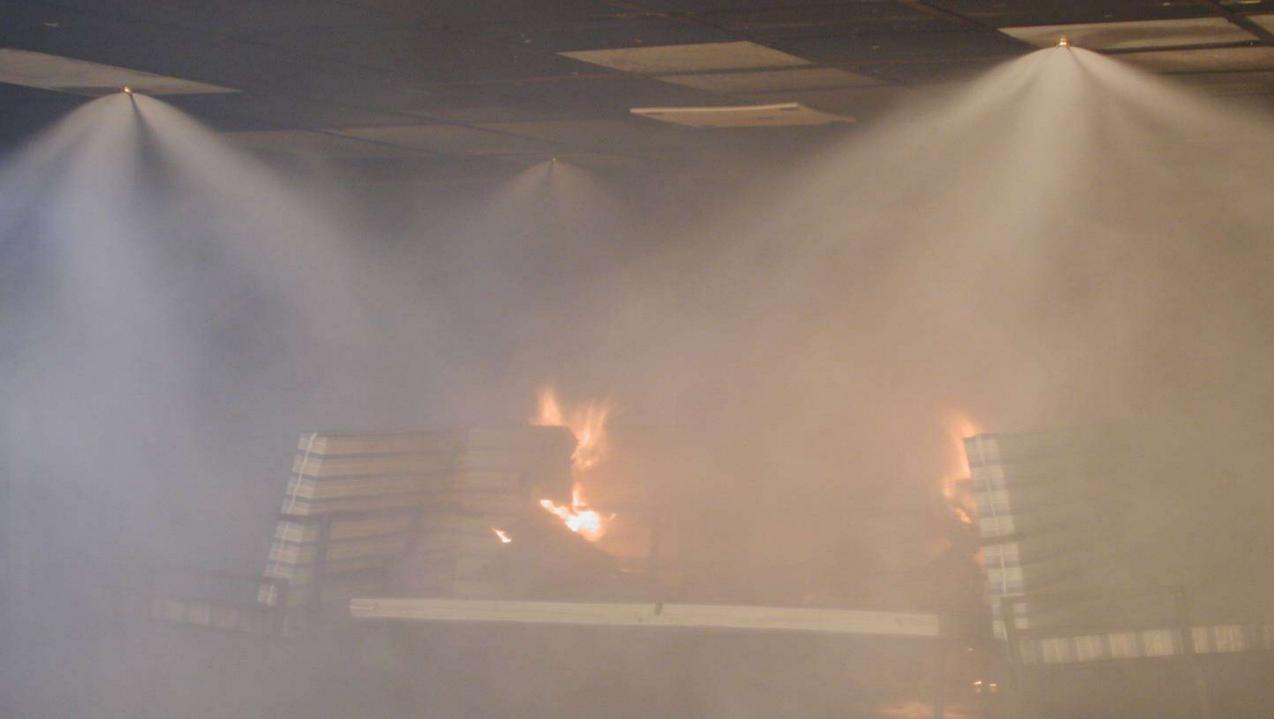
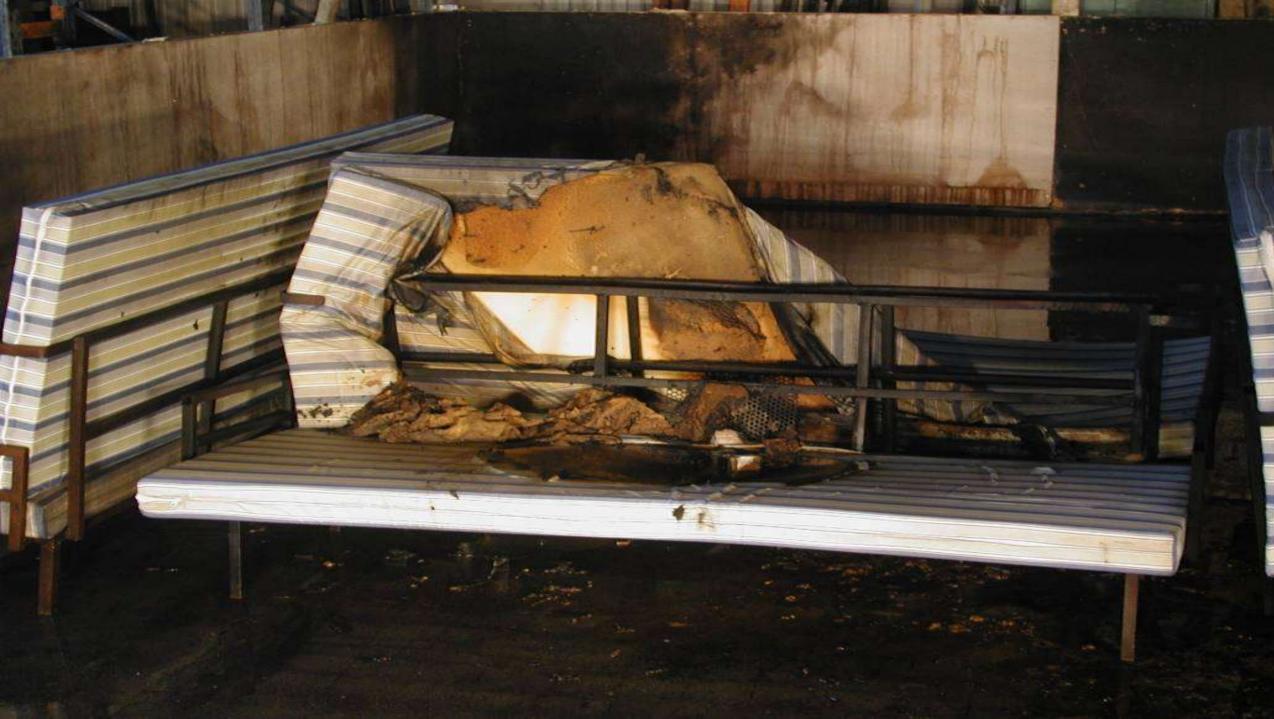
High-pressure system, 60 bar.

Low-pressure system, approximately 8 bar.

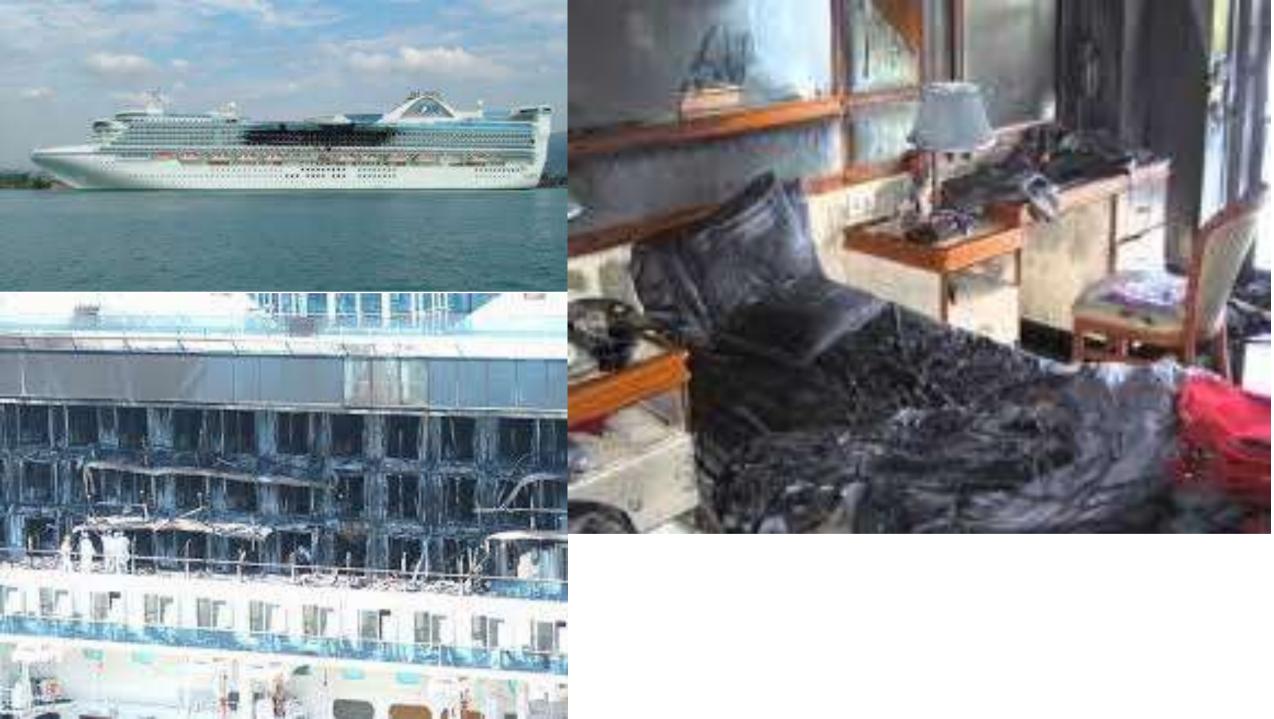
- The high-pressure system was designed for an operating area of 280 m² (about 18 nozzles) at an operating pressure of 60 bar.
- Approximately 168 nozzles activated.
- The system was operating for four hours.
- The system pressure was approximately 48 bar, using two regular pump units and a third pup unit that was manually started.
- About 300 tons of water was distributed over three decks and three main verical fire zones.
- Eight nozzles did not activate properly. For seven of them, this was due to damages to the glass bulbs.
- <u>Still, the system probably prevented a major disaster!</u>

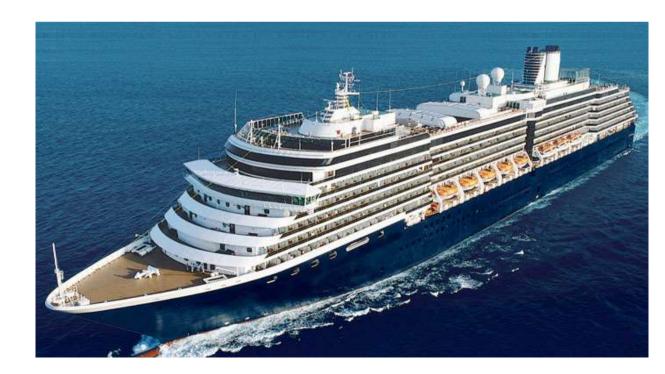
In 2012, Det Norske Veritas did a survey on four passenger ships older than ten years. The results showed that:

- Between 30% and 67% of the nozzles that were tested did not activate.
- Problems were associated with one particular make and type of nozzle.
- Further studies were recommended.
